Debris/Ice/TPS Assessment and Integrated Photographic Analysis of Shuttle Mission STS-74

Gregory N. Katnik, Barry C. Bowen, Jill D. Lin

*Gregory N. Katnik, Barry C. Bowen, Jill D. Lin,
Vehicle Engineering/Mechanical System Division/ET-SRB Branch,
Kennedy Space Center, Florida*

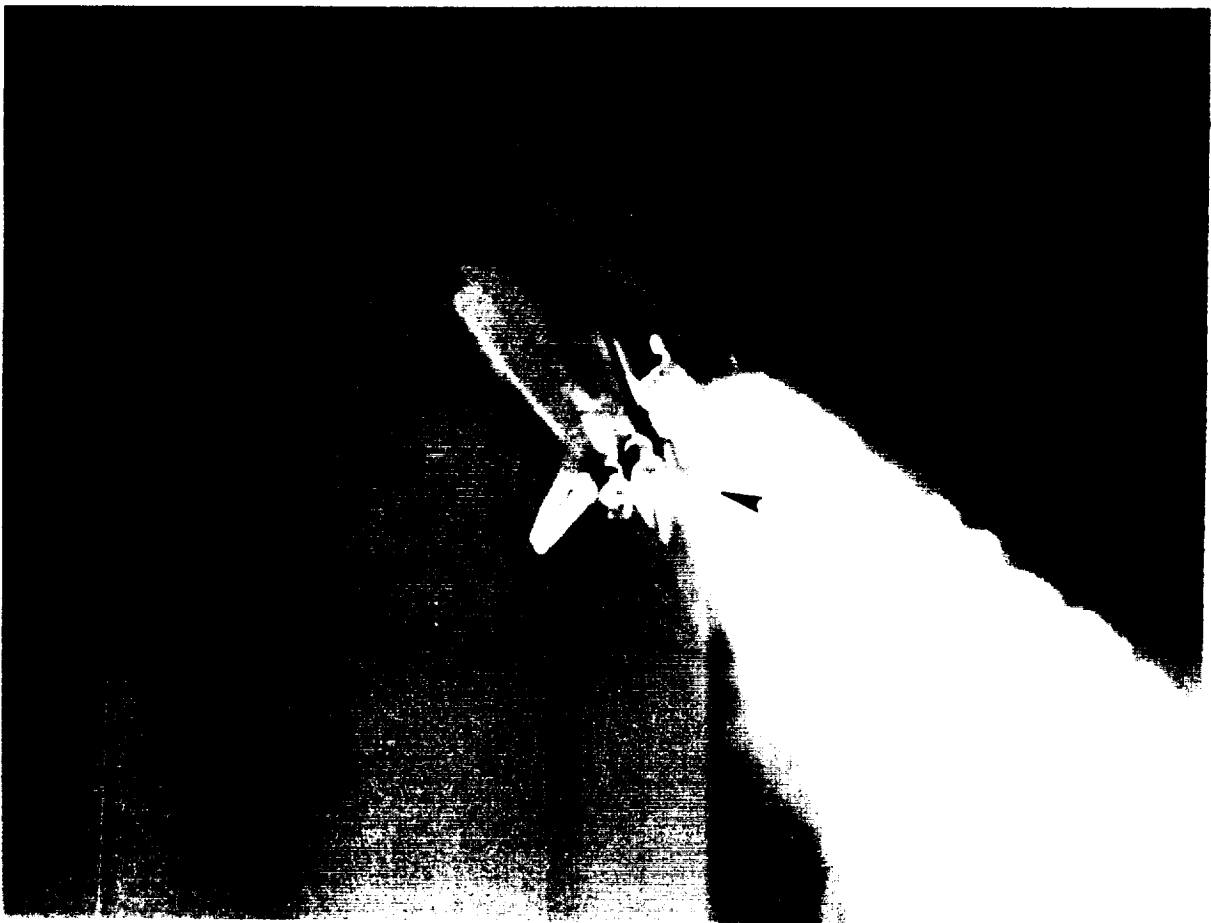
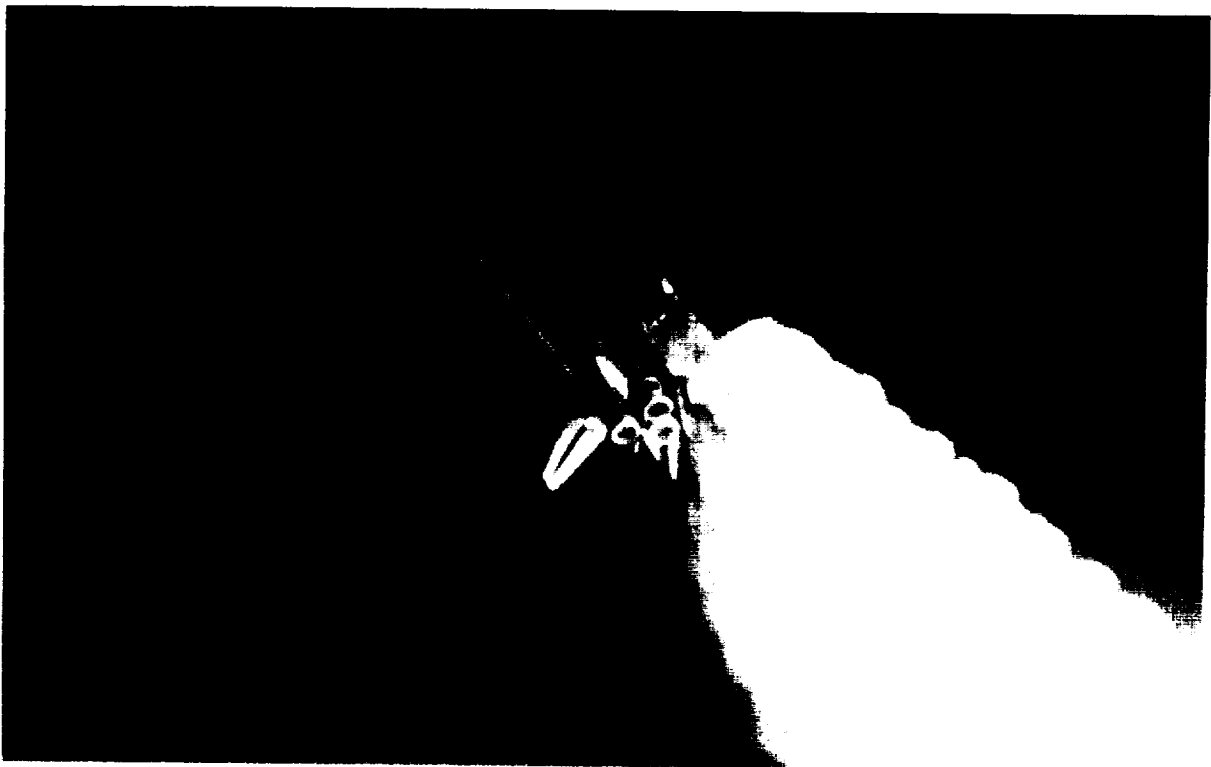
A flare in the SSME #2/#3 plume was caused by the vaporization of a light-colored object, which first appeared from an area aft of the vehicle and behind the RH SRB plume (E-223, frame 4365).

A flare in the SSME #2/#3 plume was caused by the vaporization of a light-colored object, which first appeared from an area aft of the vehicle and behind the RH SRB plume.
